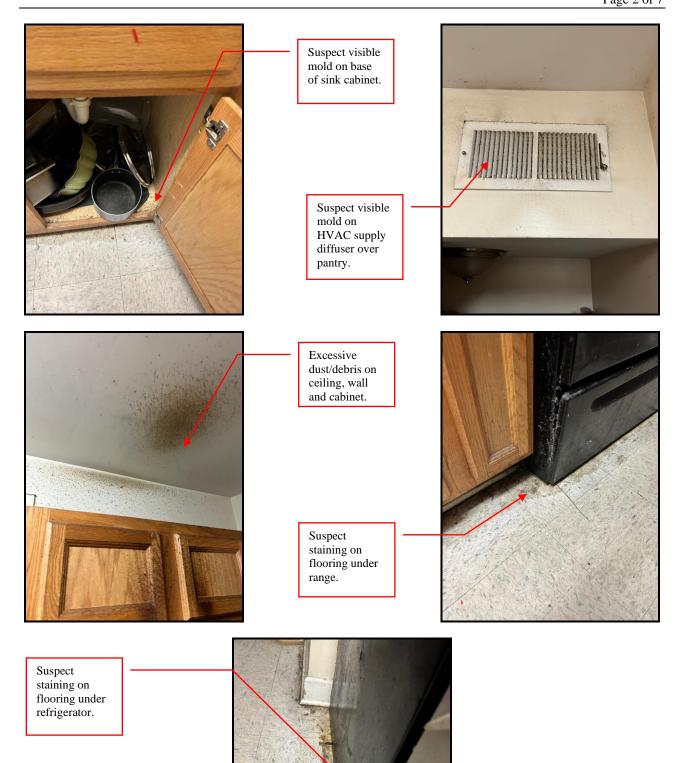
- Suspect visible mold was noted on the base of the sink cabinet.
- > Suspect visible mold was noted on the HVAC supply diffuser and adjacent wall at the front wall over the pantry.
- Excessive dust was noted on the ceiling, left wall and cabinet over the microwave. (Likely originating at the HVAC supply diffuser over the pantry.)
- Excessive dust/lint was noted behind the washer/dryer.
- Suspect staining was noted on floor tiles by the kitchen cabinets, range and refrigerator.
- ➤ Water damage and delaminating paint was noted on the ceiling over the sink.
- Moisture readings of the ceiling revealed moisture readings of less than 15.0 via GE Protimeter Surveymaster in WME (measure mode) indicating that the material is dry.

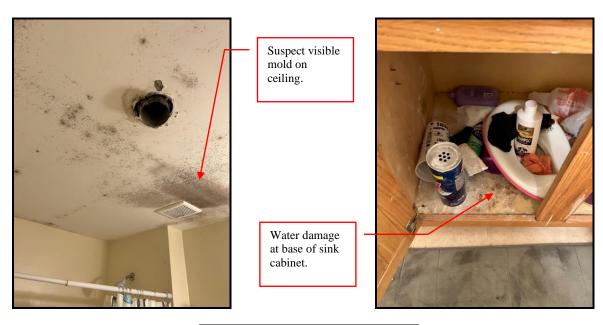
- Suspect visible mold was noted throughout the bathroom ceiling.
- Moisture readings of the ceiling revealed moisture readings of less 15.9 via GE Protimeter Surveymaster in WME (measure mode) indicating that the material is dry (given the meter's margin of error).
- Suspect visible mold was noted on the bathtub caulking.
- Water damage was noted on the base of the sink cabinet.
- The ceiling mounted HVAC supply diffuser/boot is missing and the duct appears to be improperly vented to the room.

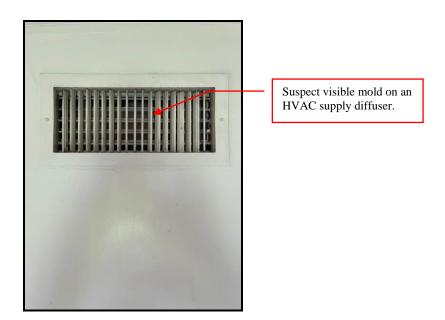
- > Suspect visible mold was noted on the HVAC supply diffusers at the following locations:
 - o Front right room
 - o Rear right room
 - Rear left room
- ➤ Water staining (caused by condensation) was noted on the wallboard walls under the HVAC supply diffusers at the following locations:
 - o Front right room
 - o Rear right room
 - Rear left room

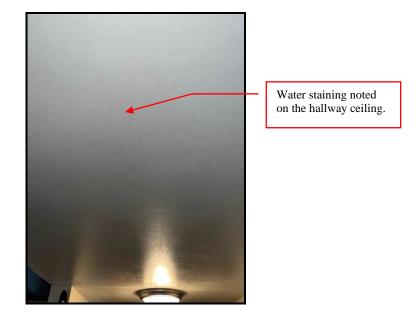
1st floor hallway

- The spore trap air sample collected within this area revealed elevated levels of *Penicillium/Aspergillus* types as compared to the sample collected at the exterior of the residence. (*Penicillium/Aspergillus* types: 1,200 spores/m³ inside vs 290 spores/m³ outside).
- > Other molds revealed in the sample indicated no significantly elevated levels of mold growth as compared to the sample collected at the exterior of the residence.
- Water staining was noted on the hallway ceiling.
- The relative humidity within the area was 44.7% which is within the ASHRAE guidelines for occupant's comfort of 30% to 60%.

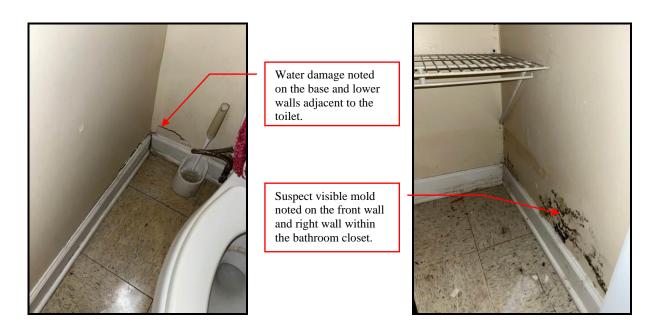
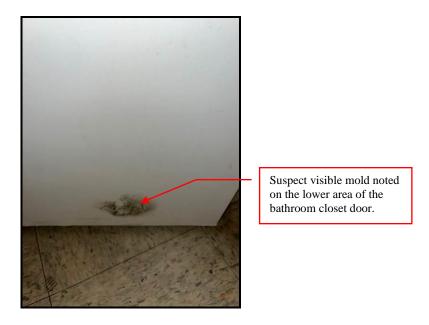
1st floor bathroom

- Water damage was noted on the base and lower walls adjacent to the toilet.
- > Dust was noted on the exhaust vent cover within the space.
- Suspect visible mold was noted on the bathroom closet front and right walls.
- Suspect visible mold was noted on the lower area of the closet door.
- Moisture readings collected within the space via GE Protimeter Surveymaster in WME (measure mode) indicated the following:
 - o Walls:
 - Rear wall by water damage: 18.8 (Borderline)

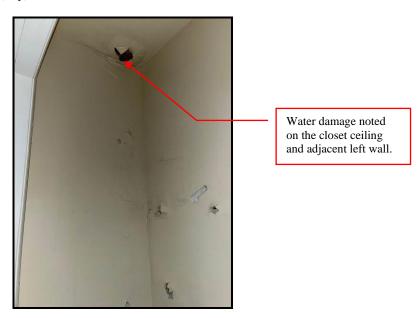
1st floor rear left bedroom

- Water damage was noted on the front left corner of the closet ceiling and the adjacent left wall.
- Moisture readings collected within the space via GE Protimeter Surveymaster in REL (search mode) indicated the following:
 - o Walls:
 - Left wall: <150 (Dry)
 - Ceiling:
 - Ceiling: <150 (Dry)

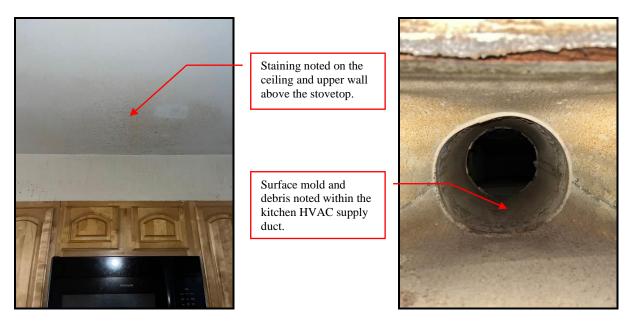
Kitchen

- The surface sample collected within the HVAC supply rigid duct revealed 3+ *Cladosporium* species and <1+ *Chaetomium* species indicating mold growth within the duct. (The lab noted a few insect parts detected).
- Staining was noted on the ceiling and upper right wall above the stove top.
- Surface mold and debris were noted within the kitchen HVAC supply duct.

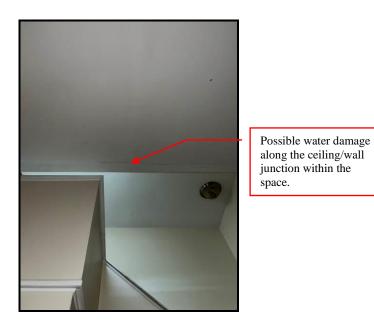
Living room

- > It was noted that there is possible water damage along the ceiling/wall junction within the space.
- Moisture readings collected within the space via GE Protimeter Surveymaster in REL (search mode) indicated the following:
 - o Ceiling:
 - Ceiling/walls: <150 (Dry)

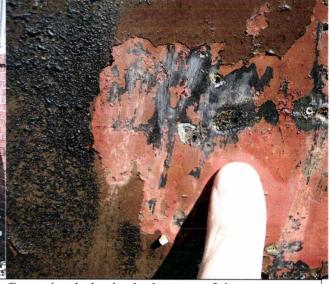
The aboveground oil tank was standing very close to the back of the house. This picture shows the tank cut open to allow interior cleaning.
