# Environmental Assessment Determinations and Compliance Findings for HUD-assisted Projects 24 CFR Part 58

Project Name: West Lumberton Flood Gate at VFW Road and Railroad Underpass

Project Location: Near Interstate 95 in the vicinity of VFW Road, Cox Road, Hackett Street, and

The City has requested HUD CDBG-MIT funding through the NCORR Infrastructure Recovery Program to construct a permanent flood gate system and related drainage improvements to prevent future flood occurrences from the Lumber River through a CSX railroad underpass beneath I-95 in an area of Lumberton that has suffered devastation, primarily associated with hurricanes. The proposed project will enhance the City's existing earthen levee system built in 1977 by the U.S Department of Agriculture (USDA) Soil Conservation Service and flood control system which protects southern and western Lumberton from the Lumber River flooding. The proposed project will disturb approximately 4.9 acres mostly within previously disturbed railroad and roadway easements and industrial businesses' lawns.

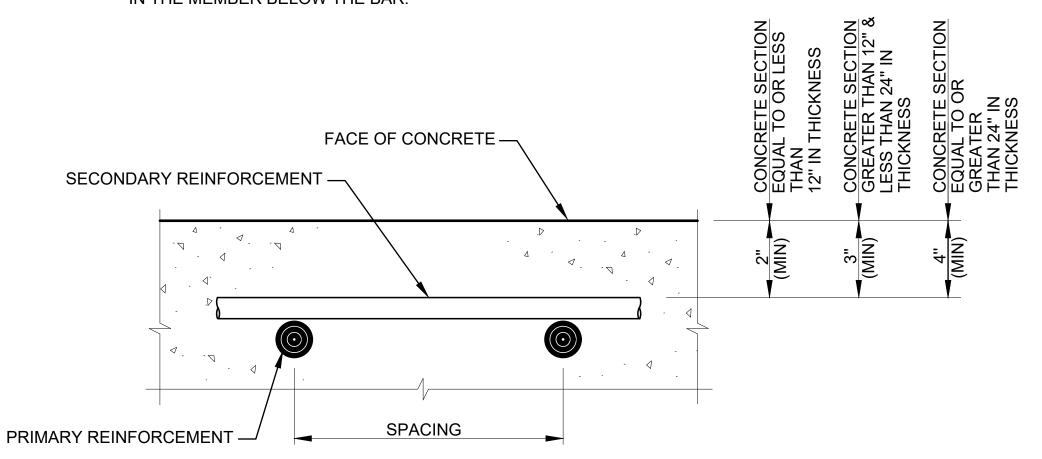
### REINFORCEMENT CLEARANCE DETAIL

- 2. THE ALTERNATE TABLE MAY BE USED IF ALL OF THE FOLLOWING CONDITIONS ARE MET: A) CENTER TO CENTER BAR SPACING LATERALLY IS AT LEAST 6 BAR DIAMETERS B) CONCRETE COVER IS AT LEAST 2 BAR DIAMETERS, AND C) EDGE DISTANCE TO THE FIRST BAR IN A LAYER IS AT LEAST 2.5 BAR DIAMETERS.
- 3. IF CONCRETE COVER OR EDGE DISTANCE IS LESS THAN 2 BAR DIAMETERS OR THE CENTER TO CENTER BAR SPACING LATERALLY IS LESS THAN 4 DIAMETERS, SEE ACI 318 FOR APPROPRIATE GUIDANCE.
- 4. TOP BARS ARE HORIZONTAL BARS AND BARS INCLINED LESS THAN 45 DEGREES WITH RESPECT TO A HORIZONTAL PLANE WHICH ARE PLACED SUCH THAT MORE THAN 12 INCHES OF CONCRETE IS CAST IN THE MEMBER BELOW THE BAR.
